# AIRCRAFT ARMAMENT

# UPDATE

## ACALA PAMPHLET 750-1-2

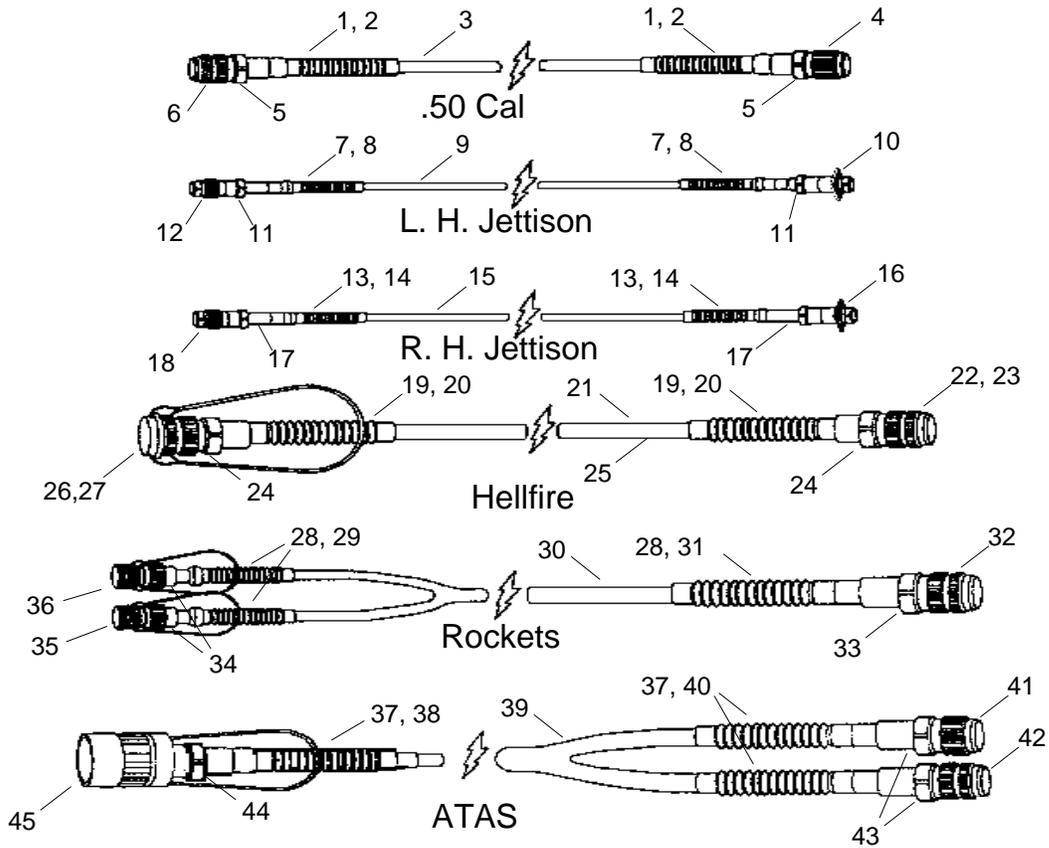
Figure C-24. Umbilical Harness Assemblies .50 cal. MG (406-075-192-107), Left Hand Jettison (406-075-192-109), Right Hand Jettison (406-75-192-111), Hellfire Missile (406-075-192-101), 2.75-Inch Rockets (406-075-192-103), and Air-to-Air Stinger (406-075-192-105)

m. Pages C-24 thru C-24-3: Recent 2028s and maintenance concept changes have resulted in corrections to figure C-24 and the repair parts and special tools list. These corrections are shown below:

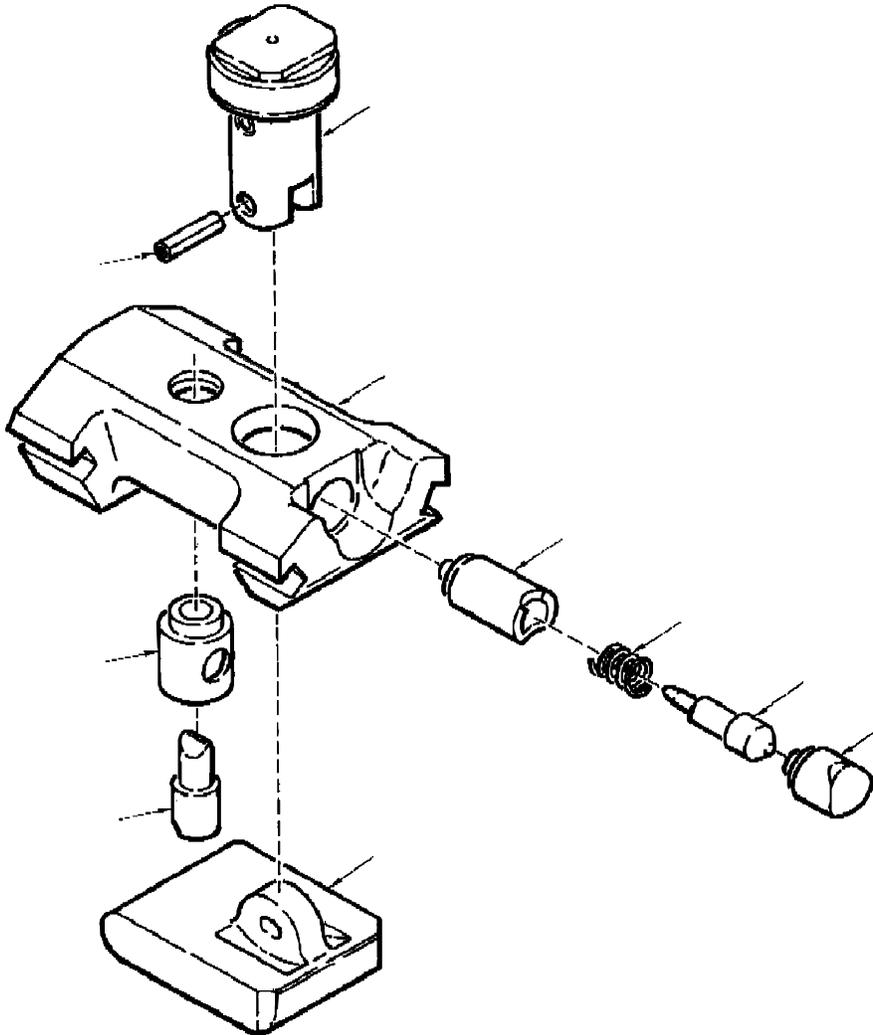
f. Figure 17, all items excluding item 2, have been replaced by a parts kit, PN 8838329, NSN 1005-01-310-7394. All breech bolt parts should be replaced at the same time.

3. **AH-1 Cobra M197 gun breech bolt parts.** Breech bolt parts on the M197 gun are now replaced as a parts kit, PN 8838329, NSN 1005-01-310-7394. All parts except the breech bolt body are replaced at the same time.
